IPACO expert report

<i>Expert name</i> Antoine COUSYN	<i>Report date</i> July 29, 2012	<i>Last update</i> February 08, 2015	
<i>Type</i> IFO	<i>Class</i> A	<i>Explanation</i> CMOS sensor saturation	<i>Complement</i>
<i>Document</i> Video	<i>Imaging location</i> Manipur, India	<i>Imaging date</i> June 19, 2011 03:11 PM local hour

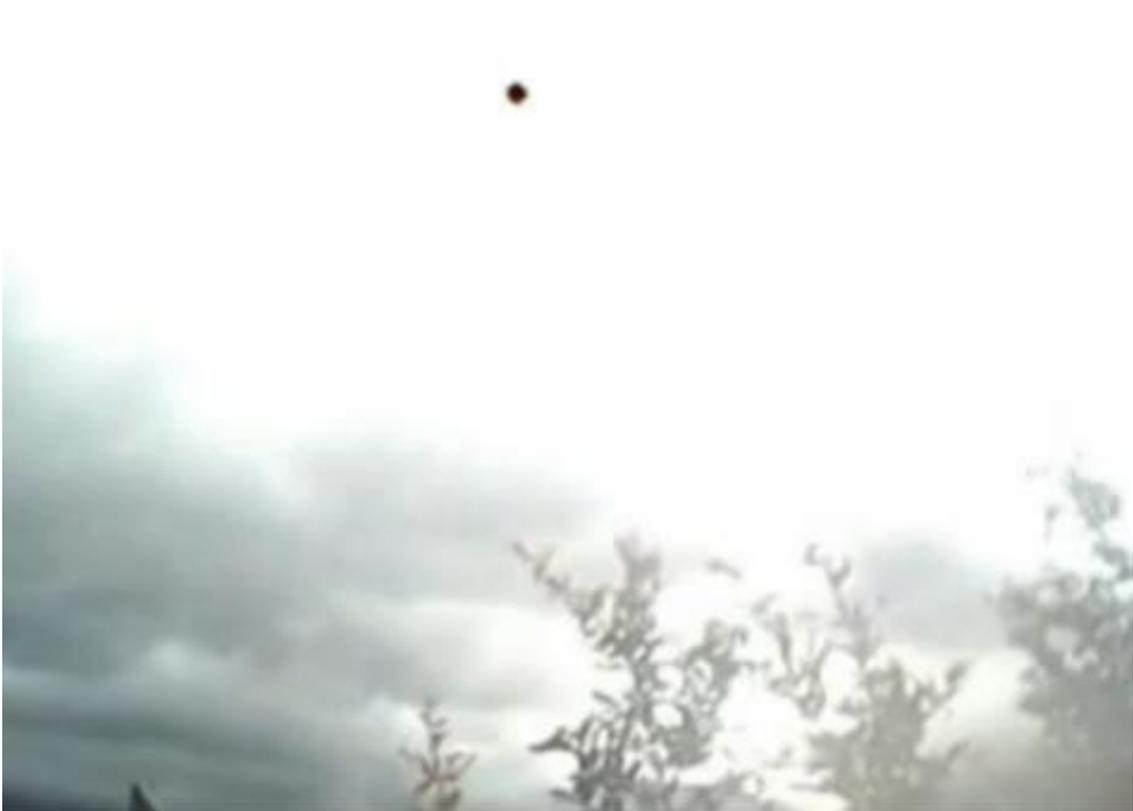
Extracted frame from the video

Careful examination of the video reveals that it was taken mainly in the direction of the sun.

Moreover, the black "UFO" remains permanently in the same place in time and in relation to fixed points of the landscape.

These data and the circular shape as well as the black color of the object suggest that it is only a saturation effect of the photographic sensor, due to the intensity of the sun and the nature of the sensor used in the camera.

Given the visual and objectives data collected by the examination of the document, we can conclude that the « UFO » is only an effect of the camera CMOS sensor overloaded by the sun light.

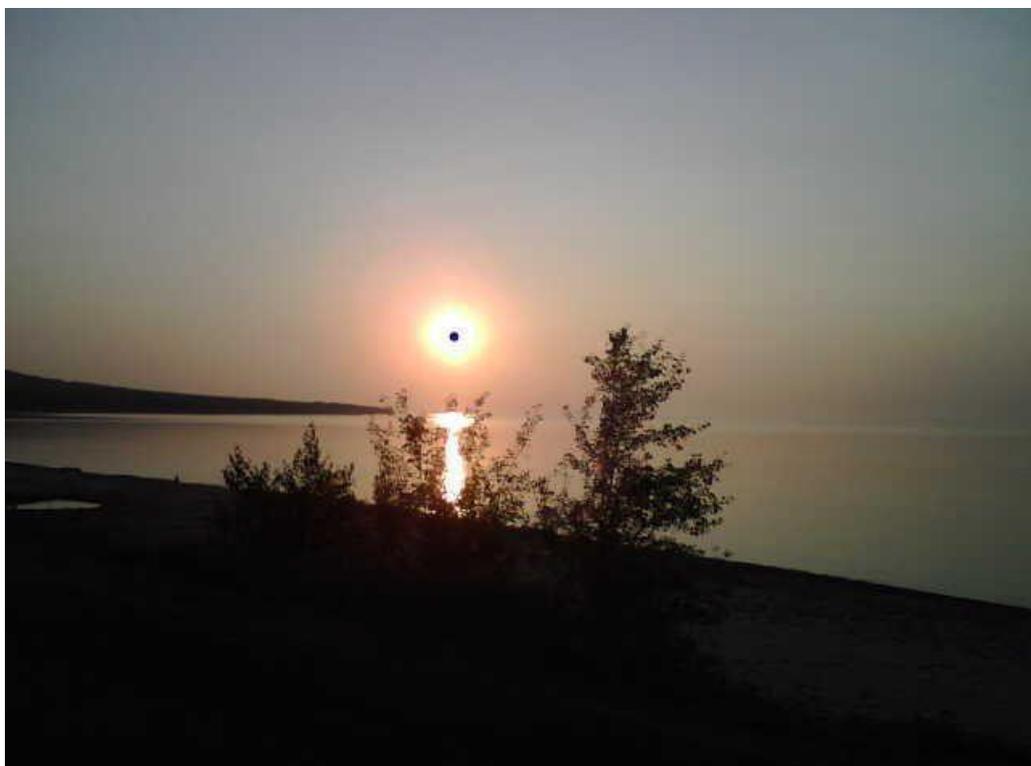
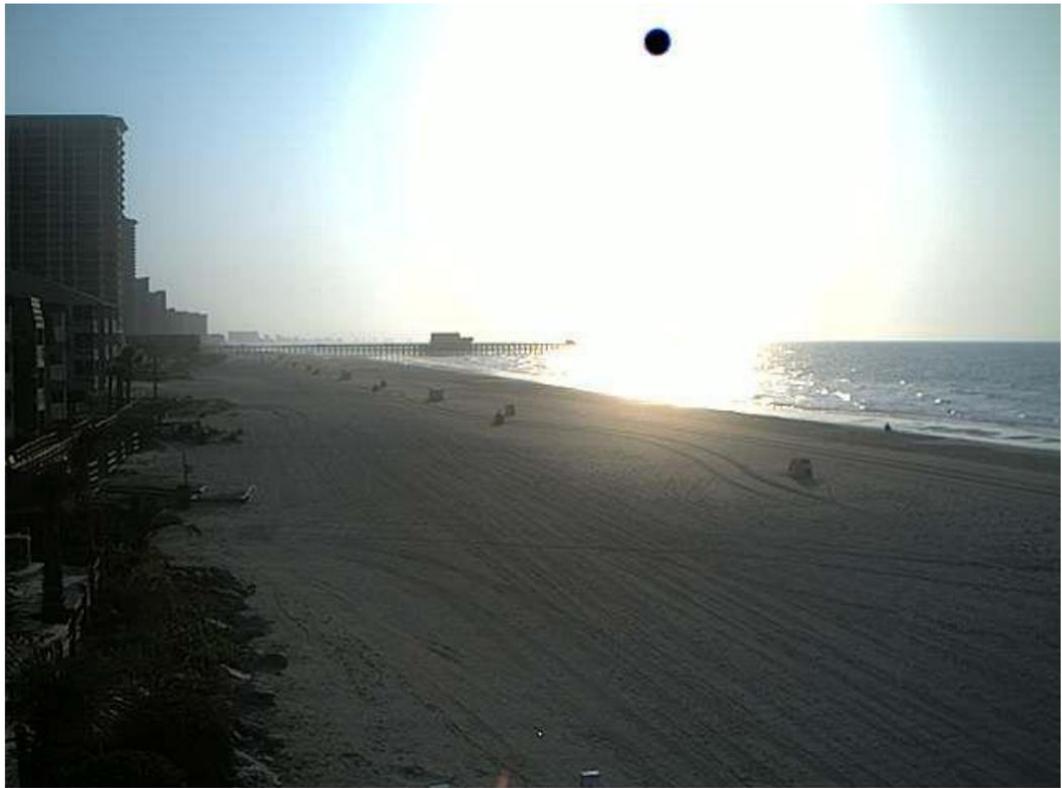
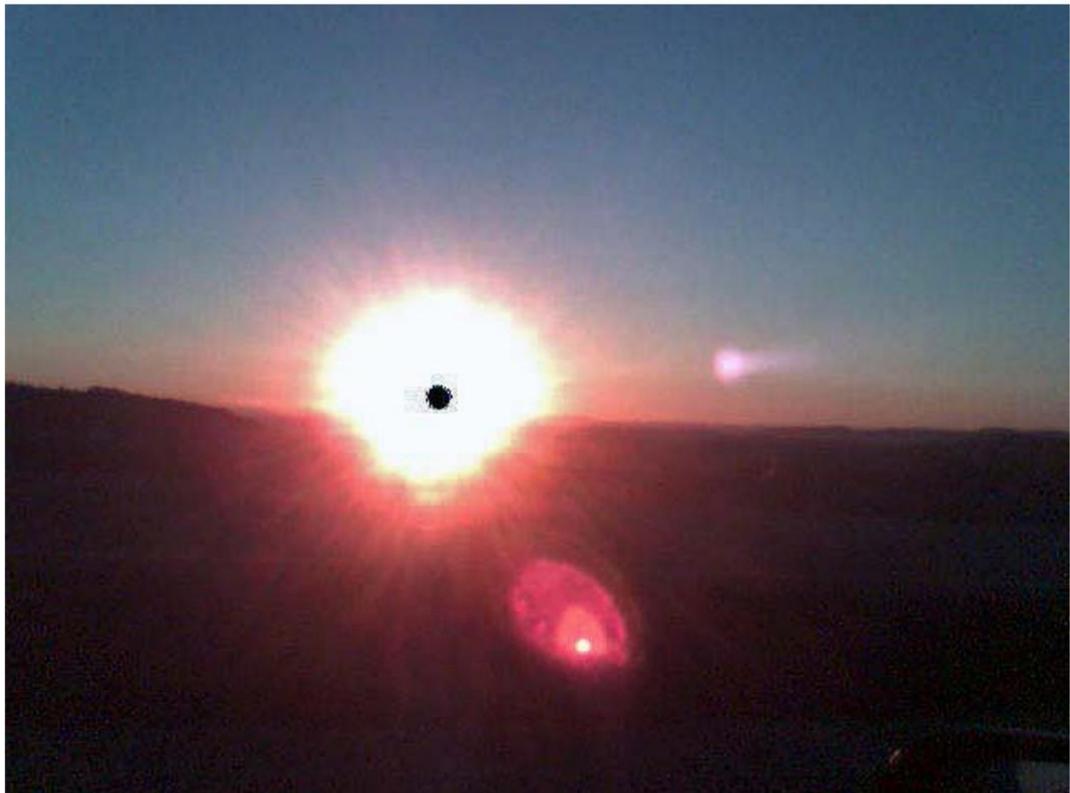
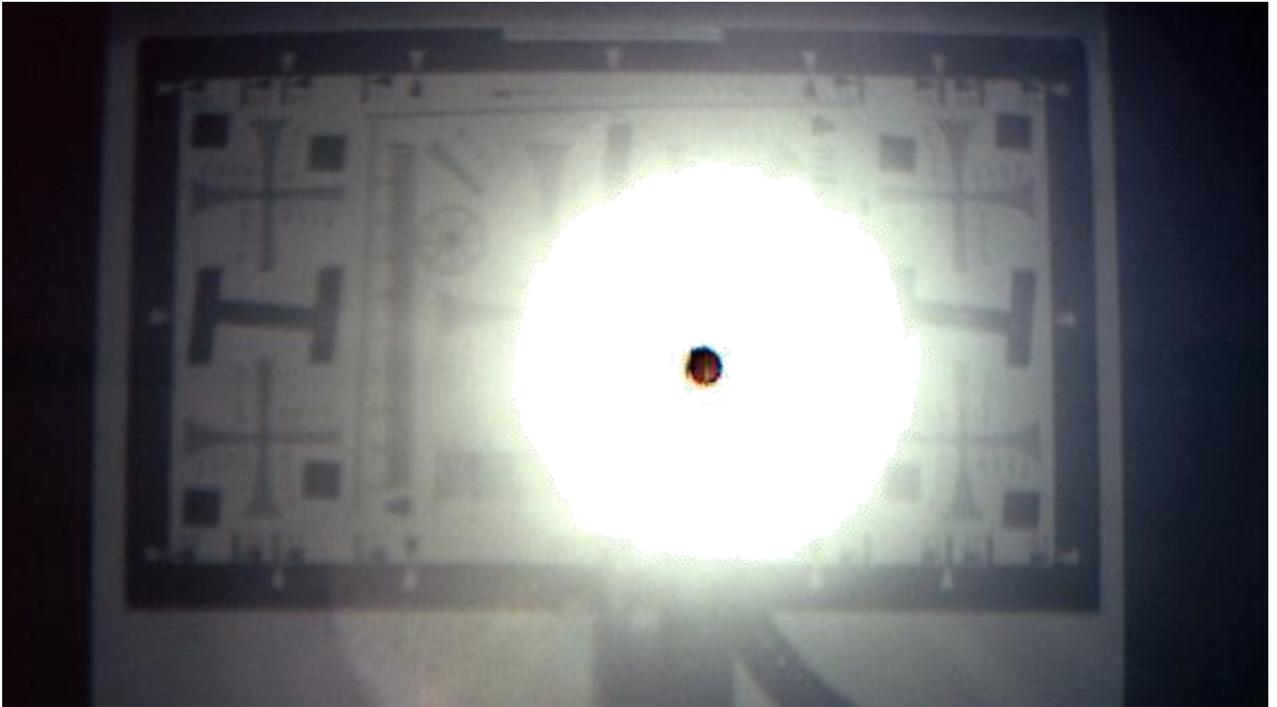
Under these conditions, we would expect the resulting image to look uniformly saturated across the image of the sun's disk or whatever bright object is in the scene. However, some CMOS sensors actually show these super-bright areas as DARK, rather than saturated, as shown below.

The last picture above shows the output end of an optical fiber bundle placed in front of a digital camera resolution chart. The input end of the fiber bundle is connected to a 150W tungsten light bulb. The measured illumination from the fiber bundle is 20000 lux. The image sensor used is an Omnivision 5610 5Mpixel CMOS sensor, operating in full resolution mode at 4 frames per sec. It is clearly evident from the picture that the central core of the fiber bundle appears black compared to the bright saturated halo around the fiber bundle.

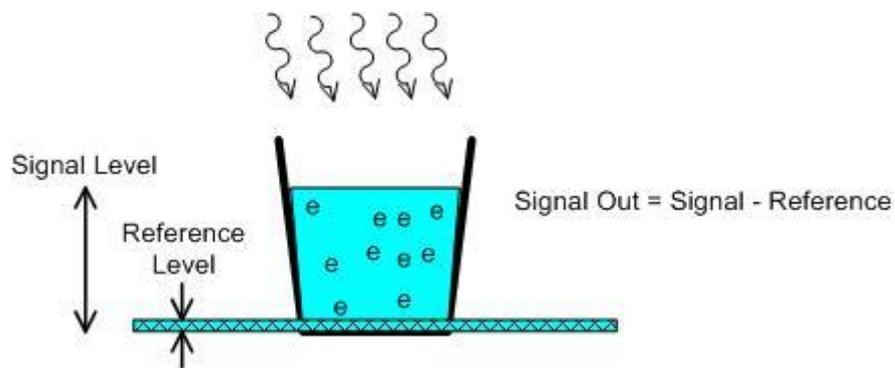
Fig. 1

A single pixel of an image sensor array can be thought of as an electrical charge 'bucket' in which photons (squiggly lines) coming in from a scene are converted to photoelectrons (small 'e's). When a pixel is read out, the level of photoelectrons is compared to a reference level of electrical charge around the pixel. In the case of imaging a very bright object, the number of photons hitting the

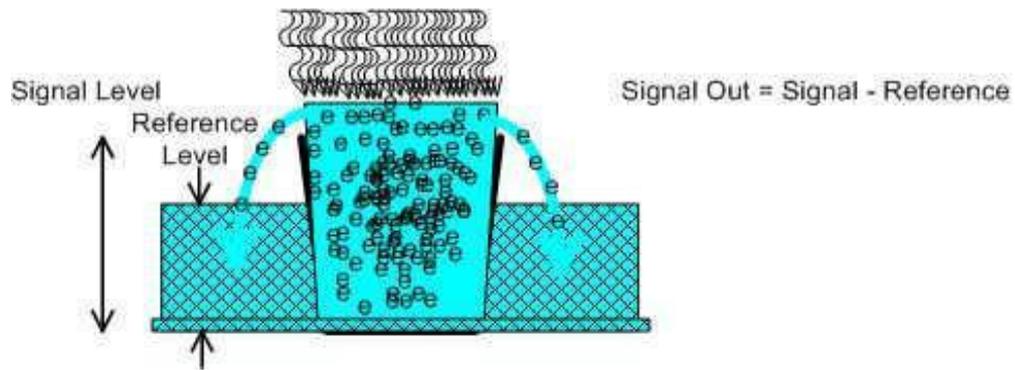
Fig. 2

pixel during a given time period (the exposure time), is far greater than the storage capacity of the photoelectron bucket (See diagram below).

When this happens, the photoelectrons converted by the pixel start spilling out into the area surrounding the pixel, temporarily raising the reference level of charge surrounding the pixel. As a result, the net signal that is read out from the pixel actually decreases because the signal level cannot exceed the full (saturated) level of the pixel well and the reference level is raised by the overflow photoelectrons. If the incident photon flux is high enough, the signal and reference levels are the same and the net output signal is zero – producing a black pixel.
