# IPACO expert report

<i>Expert name</i> Antoine COUSYN	<i>Report date</i> July 29, 2012	<i>Last update</i> February 08, 2015	
<i>Type</i> <b>IFO</b>	<i>Class</i> <b>A</b>	<i>Explanation</i> CMOS sensor overloaded	<i>Complement</i> Sun
<i>Document</i> Video	<i>Imaging location</i> Manipur, India.	<i>Imaging date</i> June 19, 2011 03:11 pm local hour

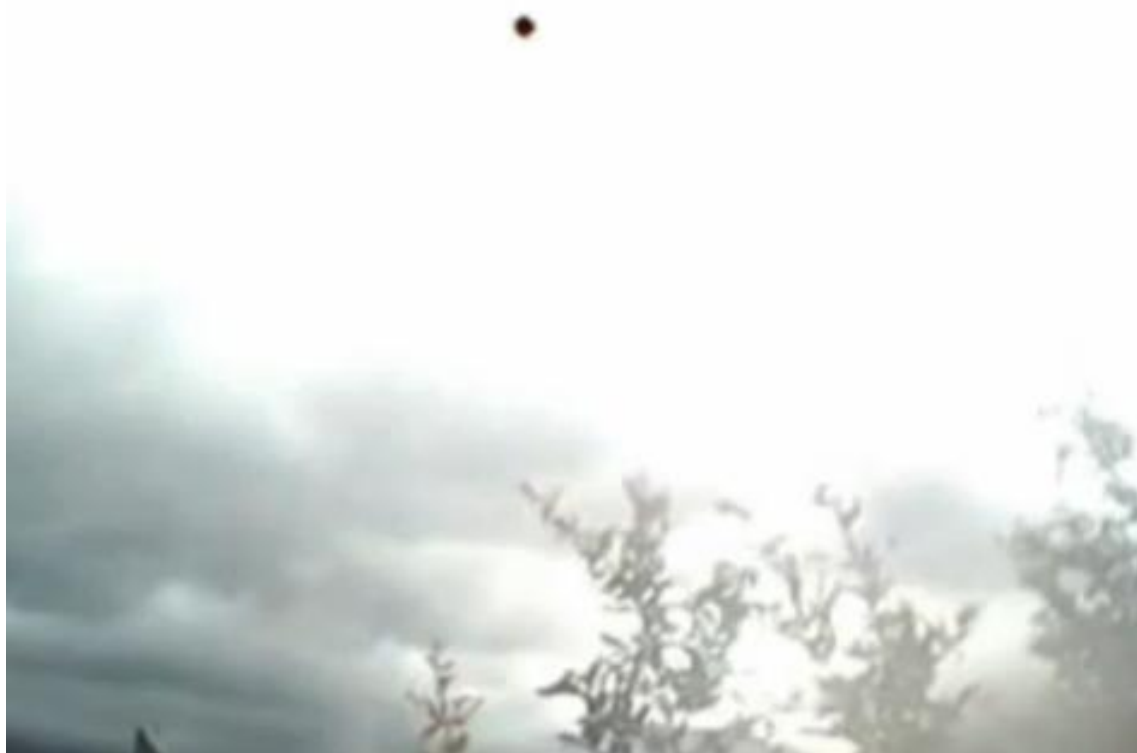
*Extracted frame from the video*

Careful examination of the video reveals that it was taken mainly in the direction of the sun. Moreover, the black "UFO" remains permanently in the same place in time and in relation to fixed points of the landscape.

These data and the circular shape as well as the black color of the object suggest that it is only a saturation effect of the photographic sensor, due to the intensity of the sun and the nature of the sensor used in the camera.

Given the visual and objectives data collected by the examination of the document, we can conclude that the « UFO » is only an effect of the camera CMOS sensor overloaded by the sun light.

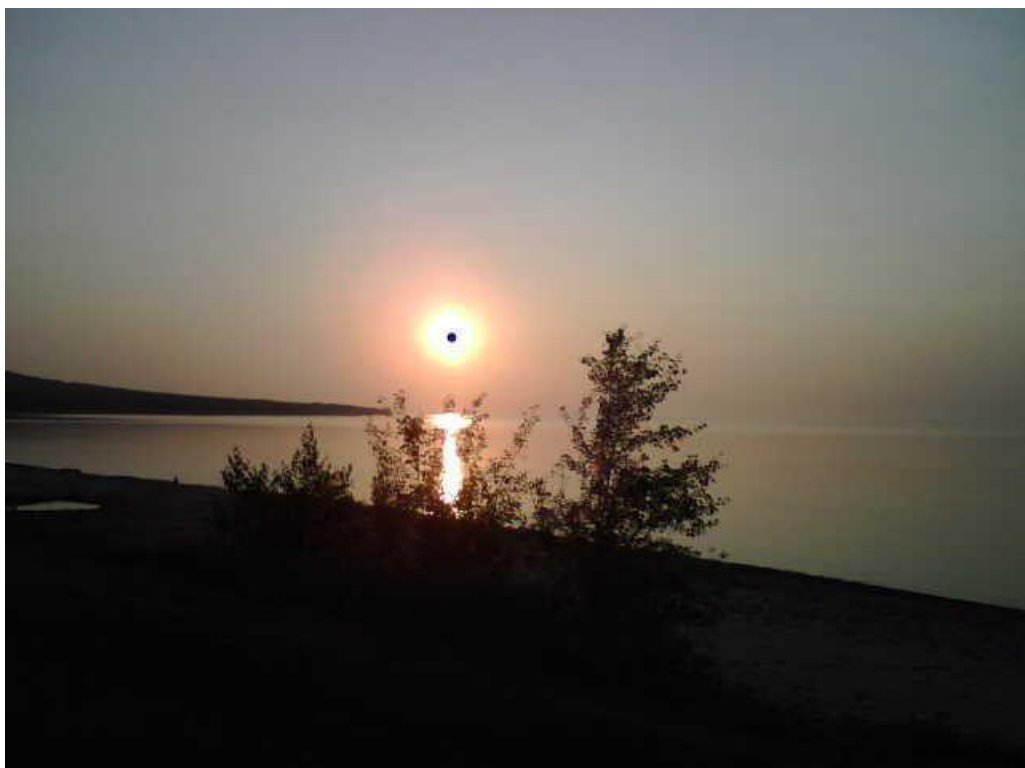
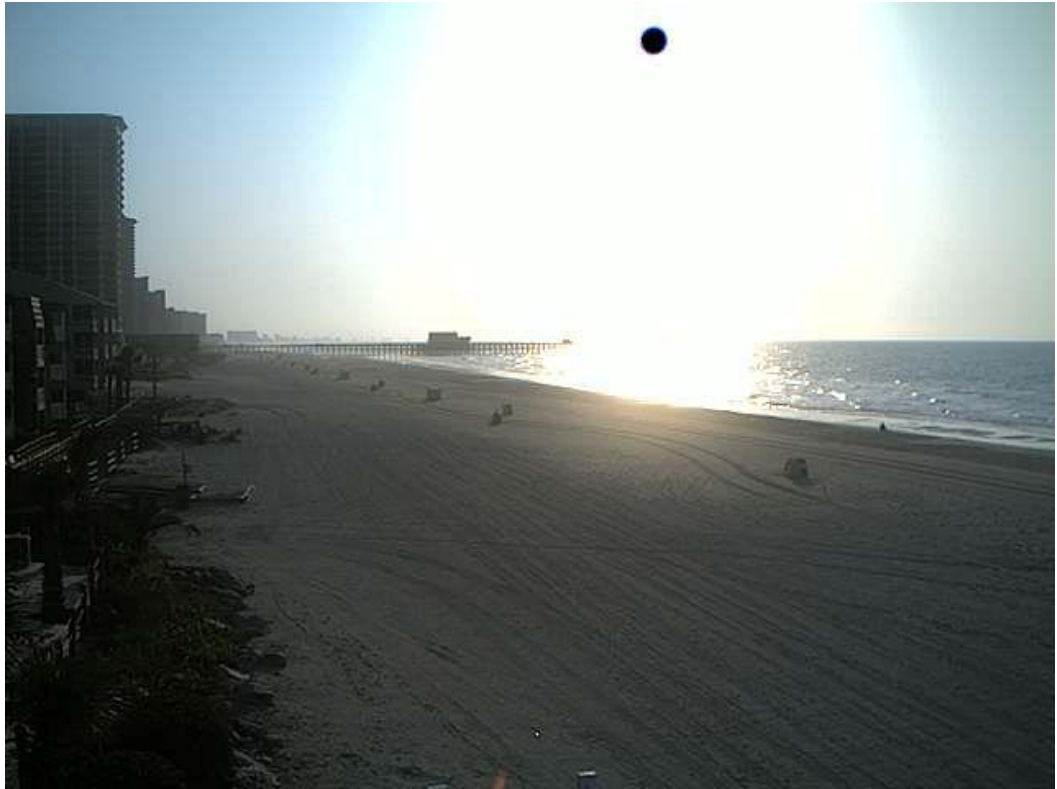
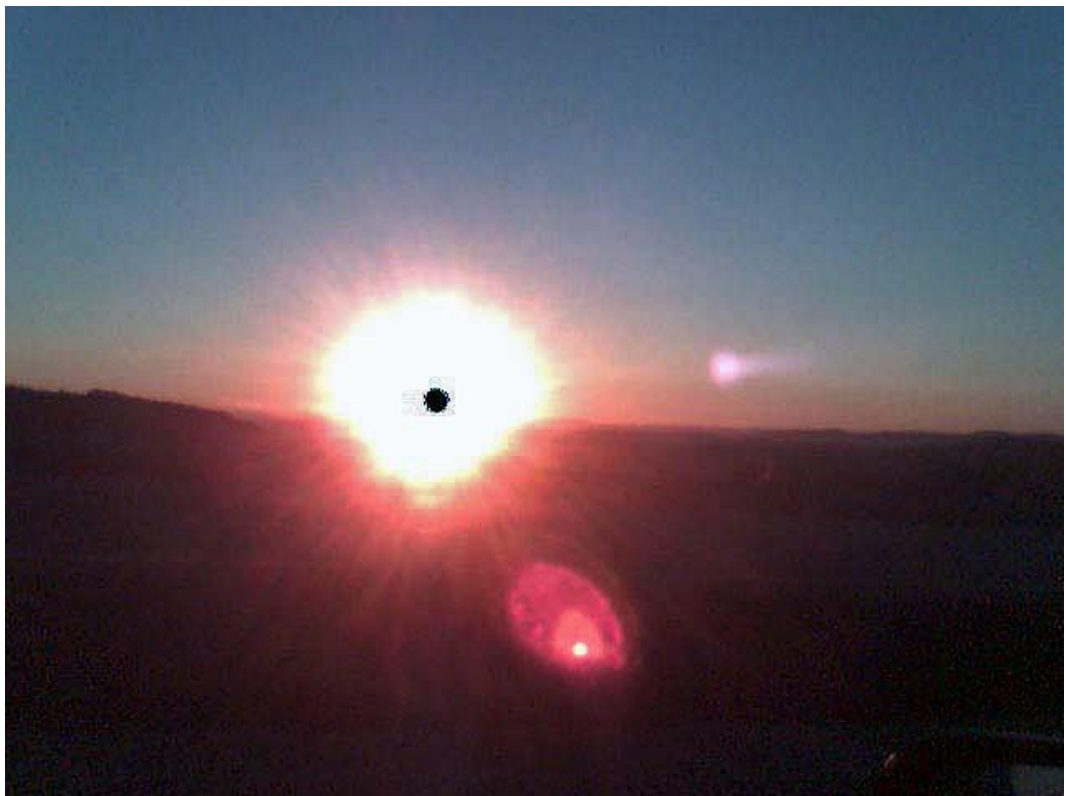
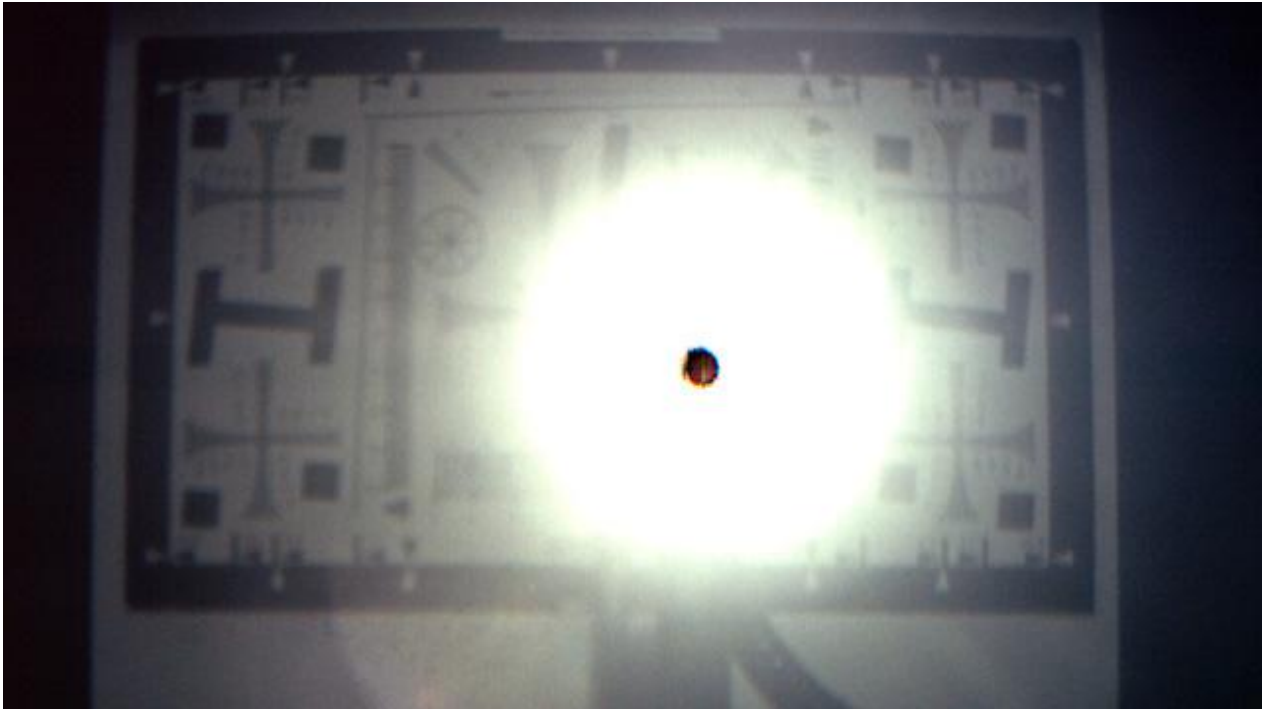
Under these conditions, we would expect the resulting image to look uniformly saturated across the image of the sun's disk or whatever bright object is in the scene. However, some CMOS sensors actually show these super-bright areas as DARK, rather than saturated, as shown below.

The last picture above shows the output end of an optical fiber bundle placed in front of a digital camera resolution chart. The input end of the fiber bundle is connected to a 150W tungsten light bulb. The measured illumination from the fiber bundle is 20000 lux. The image sensor used is an Omnivision 5610 5Mpixel CMOS sensor, operating in full resolution mode at 4 frames per sec. It is clearly evident from the picture that the central core of the fiber bundle appears black compared to the bright saturated halo around the fiber bundle.

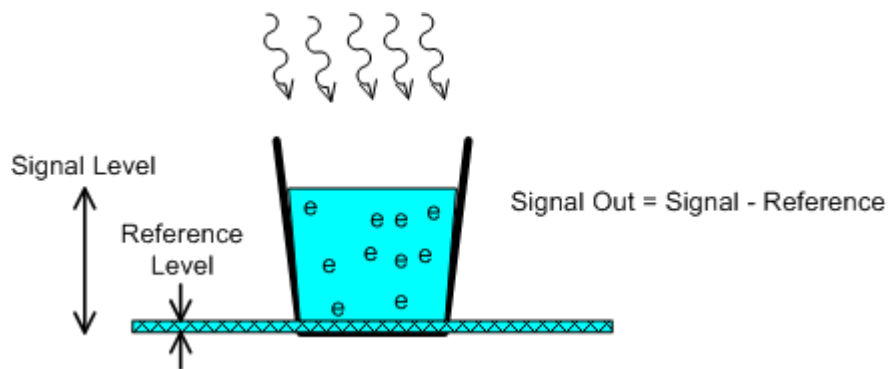
Fig. 1

A single pixel of an image sensor array can be thought of as an electrical charge 'bucket' in which photons (squiggly lines) coming in from a scene are converted to photoelectrons (small 'e's). When a pixel is read out, the level of photoelectrons is compared to a reference level of electrical charge around the pixel. In the case of imaging a very bright object, the number of photons hitting the

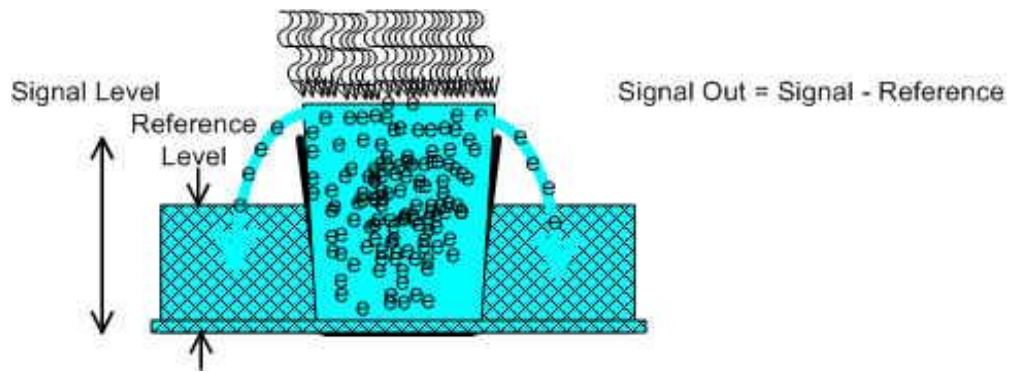
Fig. 2

pixel during a given time period (the exposure time), is far greater than the storage capacity of the photoelectron bucket (See diagram below).

When this happens, the photoelectrons converted by the pixel start spilling out into the area surrounding the pixel, temporarily raising the reference level of charge surrounding the pixel. As a result, the net signal that is read out from the pixel actually decreases because the signal level cannot exceed the full (saturated) level of the pixel well and the reference level is raised by the overflow photoelectrons. If the incident photon flux is high enough, the signal and reference levels are the same and the net output signal is zero – producing a black pixel.
