IPACO expert report

Flap track pods fairings
streamlining the flap
mechanisms

Over Heathrow, UK.

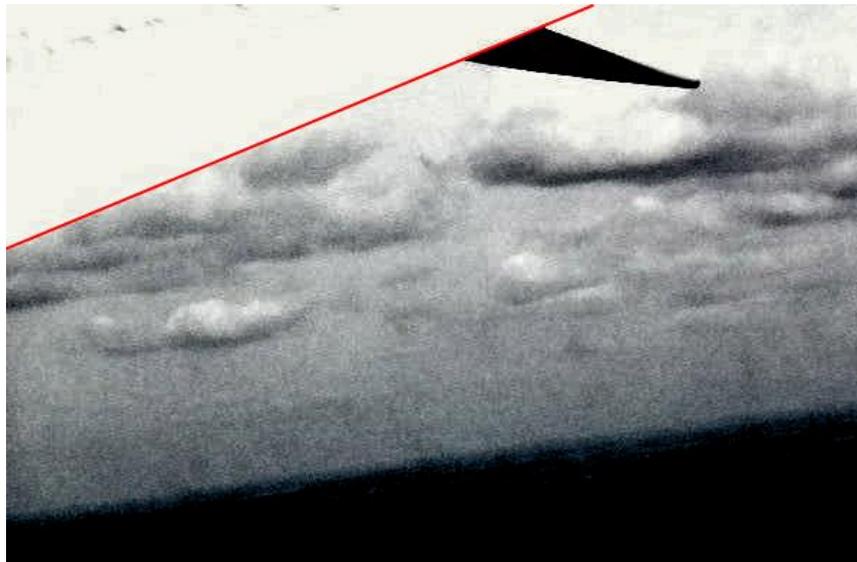
However, a simple contrast and brightness enhancement of the photograph shows a clean limit in the upper left corner that indicates the presence of a uniform saturated area, occupying the entire corner above and at the left of the object:

This zone, saturated in luminosity, is barely visible in the original photograph as it can be confused with the high brightness of the white clouds lying in the background sky.

Given the objective data provided by the examination of the photographic document, we can conclude that the object contained in this document is a slide rail component of an airplane wing; the saturation of the brightness of the photographed area making this wing almost indistinguishable, in contrast with the dark area of the rail not exposed to the sun.

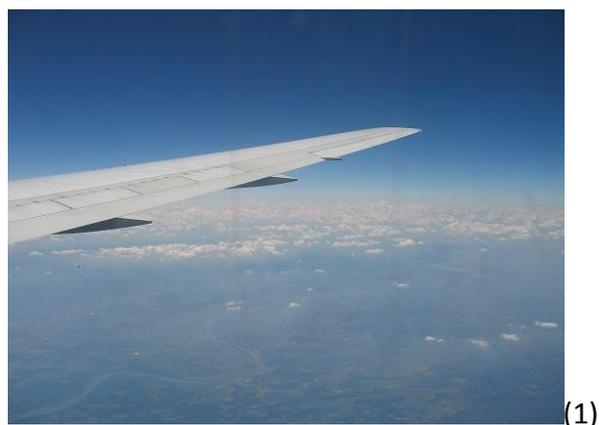
(1)

...which is only a part of this one:

The triangular dark areas under the wing of the aircraft are in fact only the supports of the wing flaps, visible here more closely, on an Airbus A380-800:
